THE EFFECT OF SEDIMENT REDUCTION INTO WETLAND ON KUSHIRO WETLAND RESTORATION PROJECT

Taroyamamoto⁽¹⁾, norioishida⁽²⁾&toruozawa⁽³⁾

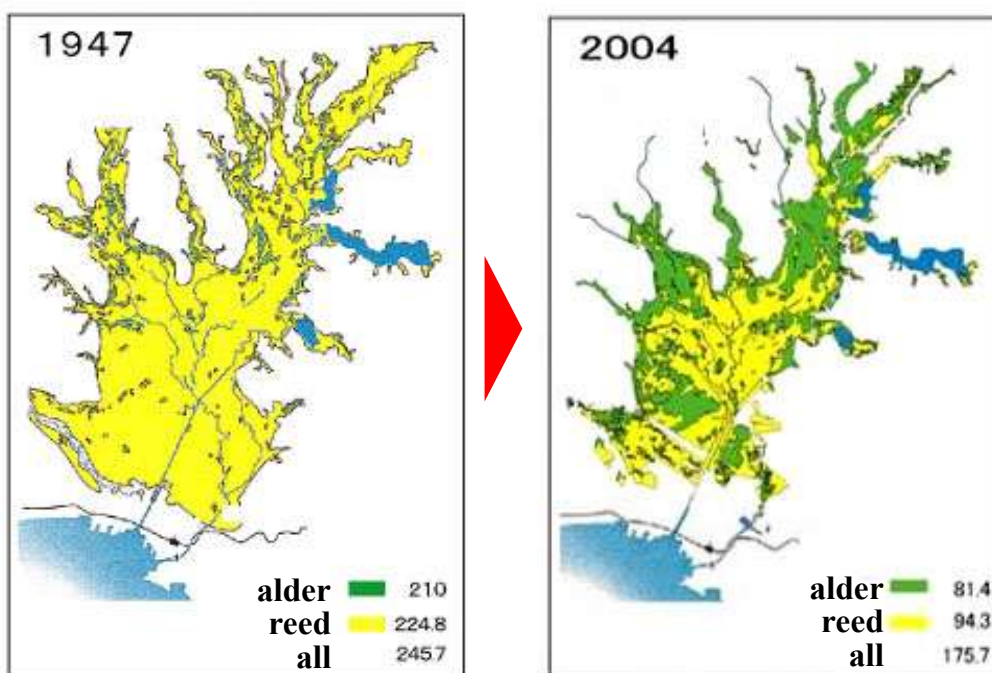
Figure 2. In the early 1900s, whole area of the wetland was covered by reed communities, however, alder trees have been invading the vegetation by 30%. Vegetation alteration triggered the commencement of the wetland

restoration project in Kushiro Wetland.

Although such a valuable wetland environment, a serious problem has occurred at the wetland since several decades ago. The wetland vegetation had been changing gradually. Most of the vegetation in Kushiro wetland had been reed and sedge community originally. However, alder forest had been invading to the wetland and the ratio of reed and sedge meadow area was decreased from 92% in 1947 to 54% in 2004(Figure 2).

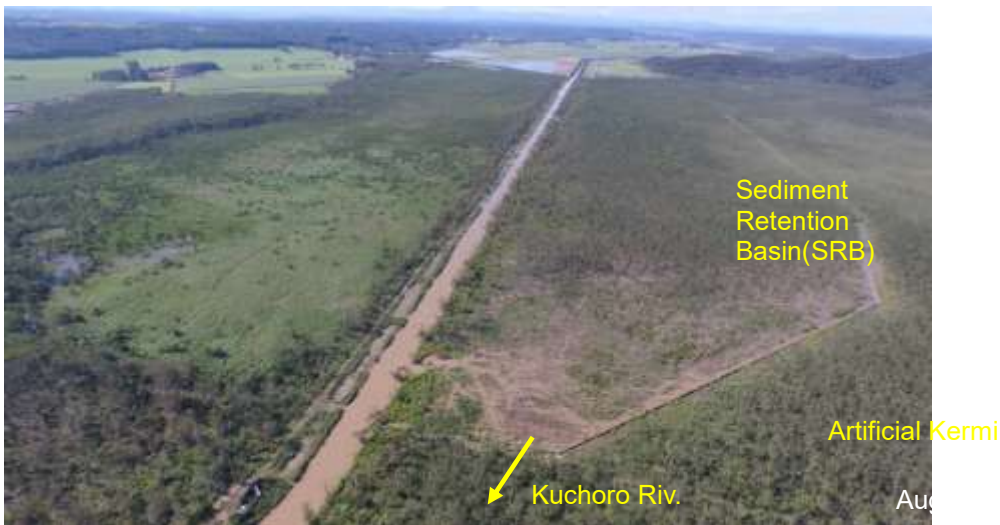
Figure 3. The Sediment Retention Basin (SRB) was constructed on the side of flood plain area at Kuchoro River. A large amount of flood water flowed into the SRB and lots of sediment were deposited there on 2016 flooding.

Sediment reduction efforts have been conducted in some districts of Kushiro Wetland Restoration Project. The Sediment Retention Basin (SRB) is one of the major efforts and was planned on both side of flood plain area at Kuchoro River, the branch of the Kushiro River(Figure 3).

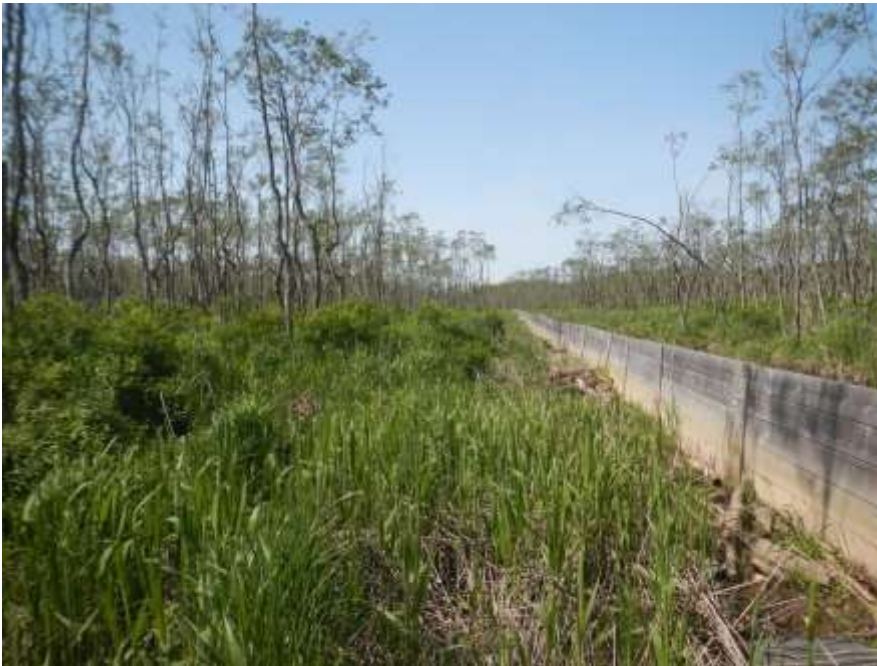
Figure 4. The SRB is the area surrounded low wall made of wooden boards. The wall was named Artificial Kermi, derived from ridge of peat moss in Finland.

The SRB is the area surrounded with low wall and the objective is to reduce sediment intrusion into the central wetland by impounding inundated flood water and depositing the dissolved sediment in it. The low wall was made of wooden boards named Artificial Kermi(Figure 4). The original kermi is ridge of peat moss mostly found in bogs in Finland.

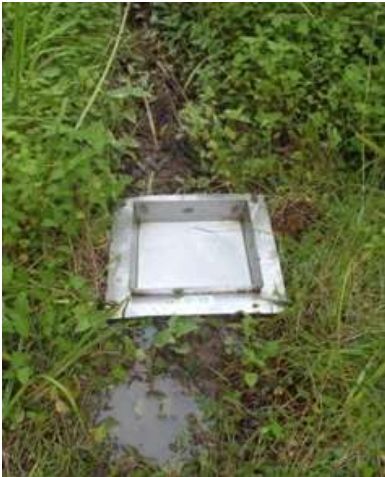
Figure 5. Sediment Trap: Square plates were set on the ground surface in the area. Sediments remained on the plate after inundation.(size: 0.22m×0.22m)

In the SRB, sediment traps had been set at 21 points on the ground and the thickness of deposited sediment was measured after flooding, and the amount of sediment deposition in the SRB was estimated(Figure 5). The difference between the influx of suspended load at the upstream of the SRB and the amount of sediment deposition in the SRB is the quantity of sediment flowing into the wetland.

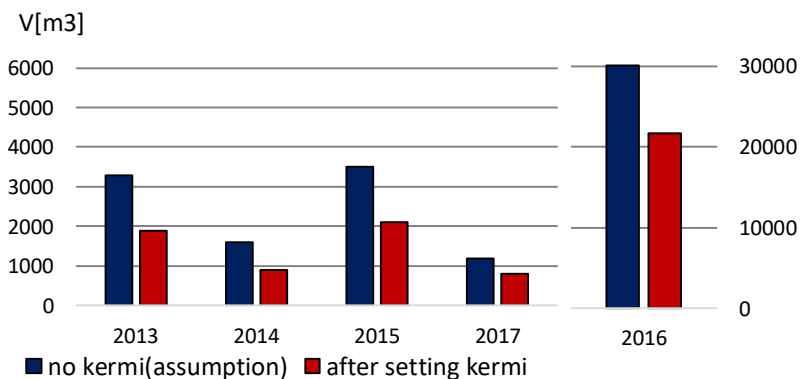
Figure 7. Estimated annual sediment inflow to wetland by numerical simulation

Calculation results of the 2016 flood are shown in Figure 6. The figure above shows the case with no SRB, and the figure below shows the case with SRB. The result of the case with no SRB showed that much sediment flowed into the wetland area and the case with SRB showed that much sediment deposition occurred. In addition, the annual amount of sediment reduction was estimated utilizing this calculation model. As a result, it was shown that the amount of sediment reduction effect was about 30% by setting the SRB(Figure 7).

The effect of Sediment Retention Basin (SRB) set to decrease in sediment intrusion into Kushiro Wetland was validated by field investigation and numerical simulation. Sediment accumulation observed in SRB after flooding and numerical results showed that the sediment inflow to the wetland is reduced by about 30%. We will continue to conduct monitoring investigation and confirm the effects.
